INVISION™ Total Ankle Revision System

Revision of a Failed Agility Total Ankle Replacement with an INBONE™ II Tibial Component and an INVISION Talar Component

CASE STUDY

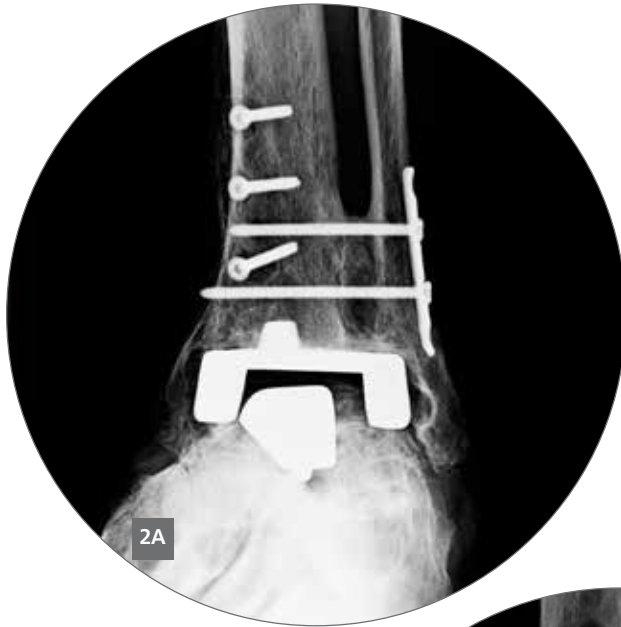
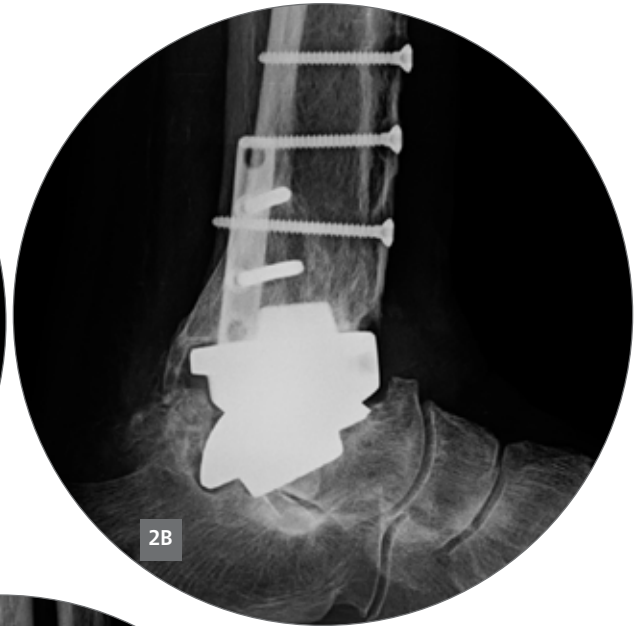
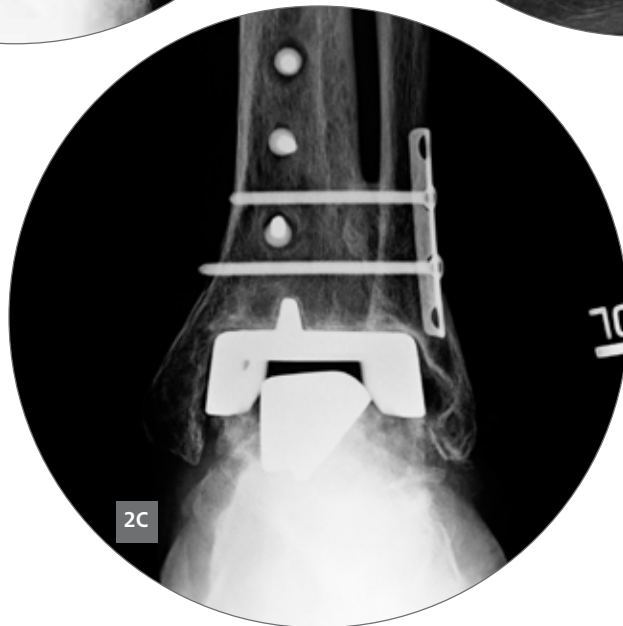
Radiographs confirmed severe talar component subsidence and presence of the anterior strut graft in the tibia (FIGURES 2A, B, and C).

The patient had pathology on multiple levels. As noted above, he had severe posterior subsidence of the talus into dorsiflexion. The posterior portion abutted the subtalar joint, which was grossly arthritic. Fortunately, the adjacent joints showed very little arthritis. The tibial component has equal challenges. An anterior strut graft supports the anterior distal tibia which bears at least 70% of the load during weight bearing. He had anterior subsidence of the tibial tray upon that graft and in the coronal plane had very little remaining medial and lateral malleolar bone.

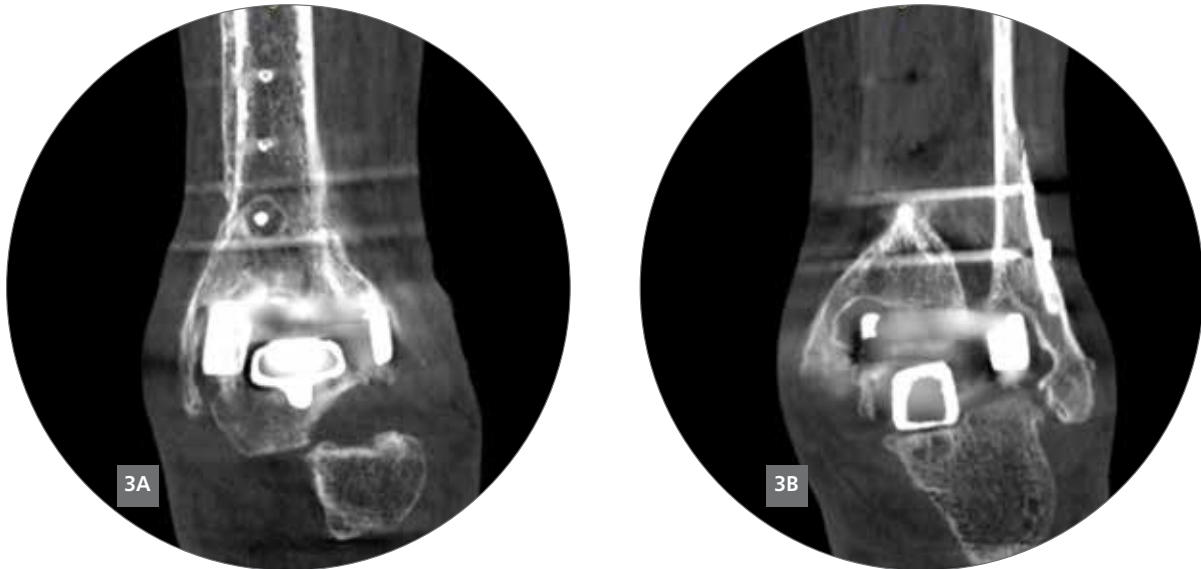
Weightbearing CT scan showed successful union of the syndesmosis, which is a positive sign on the scan. Coronal imaging confirmed thinned medial and lateral malleoli, with the wedge of the talar component splitting the talus more medial than lateral (FIGURES 3A and B).

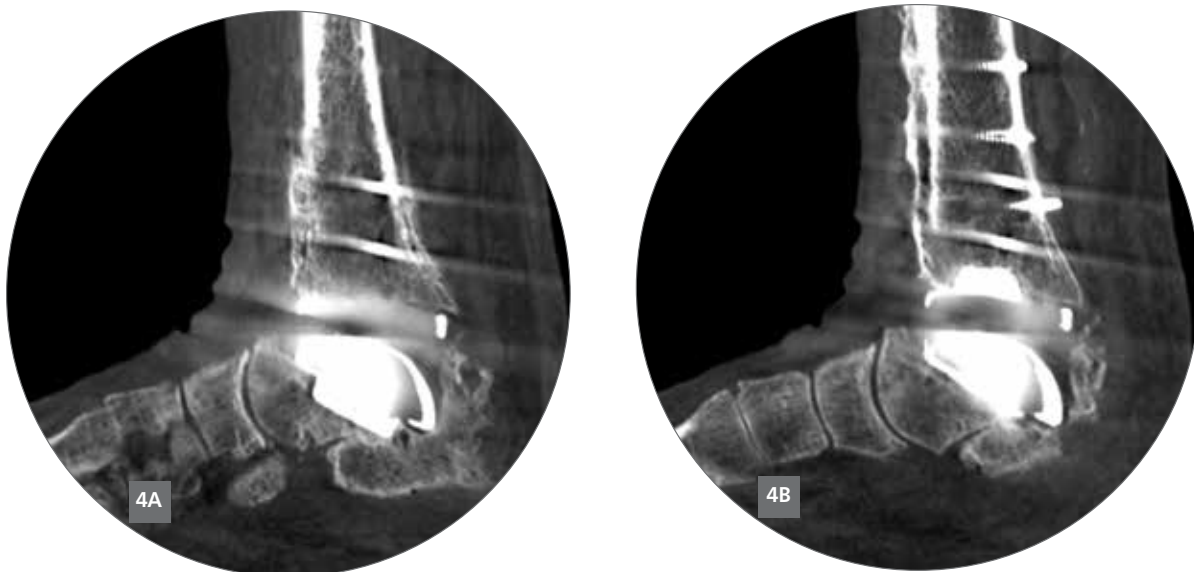
Sagittal CT imaging demonstrated a successful first tarsometatarsal joint arthrodesis and significant loosening of both components, but fortunately showed good quality anterior strut bone to support a revision prosthesis (FIGURES 4A and B).

Given the severe subsidence of the talar component and the arthritic subtalar joint, a two-stage procedure was planned. The first surgery would include removal of all hardware, a subtalar joint arthrodesis, and implantation of a temporary block cement spacer to prevent collapse and maintain joint height while the subtalar fusion was taking place. The second surgery, to remove the cement block and implant the INVISION total ankle, would take place eight months later. Four months is normally considered sufficient, but given the patient's age category, we wanted to be certain the subtalar joint fusion was solid and his bone quality was not osteopenic prior to undertaking the revision total ankle replacement.

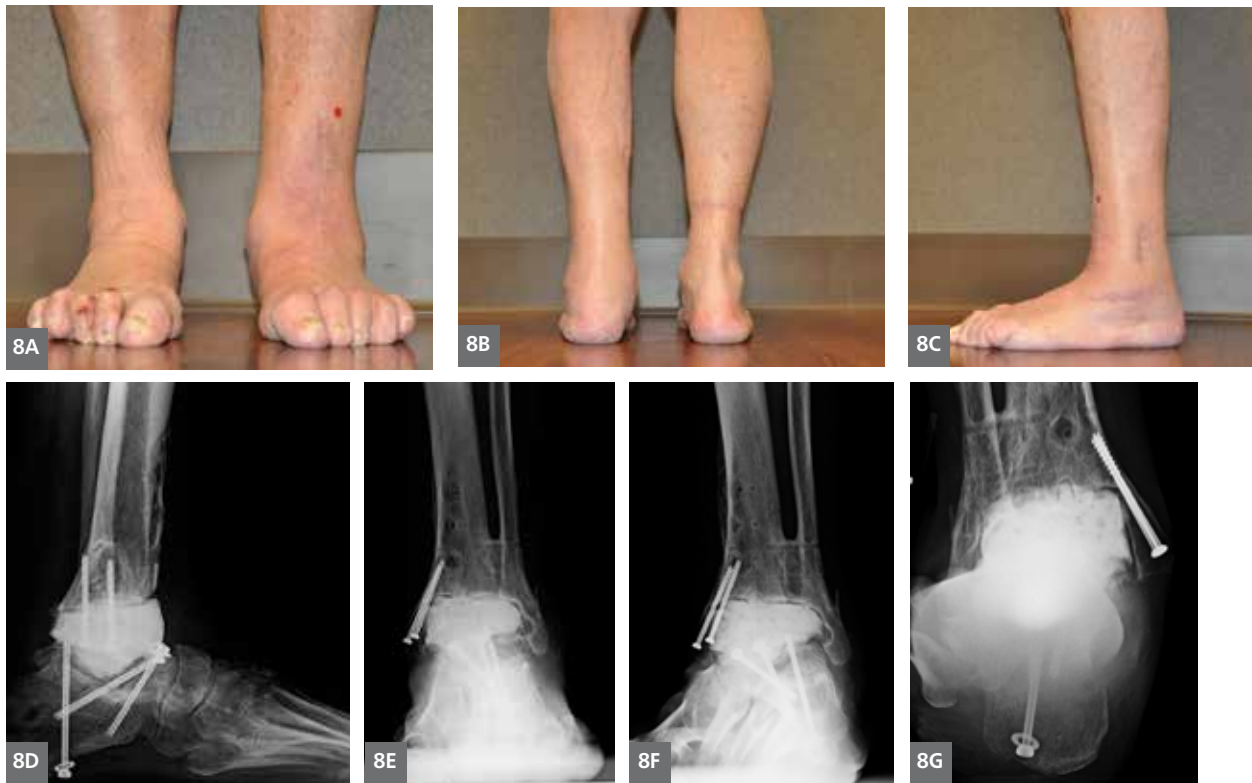
At three months postoperative, alignment was assessed through gait and standing observation in order to determine if supplementary osteotomies would be required at the second stage. CT scan confirmed subtalar arthrodesis, and it was evident that the bone mass would be able to support an INVISION implant, as it had been supporting the cement spacer without compromise. The patient was allowed to walk unrestricted in the CAM boot at three months postoperative to stimulate bone growth (FIGURES 8 A, B, C, D, E, F, and G).

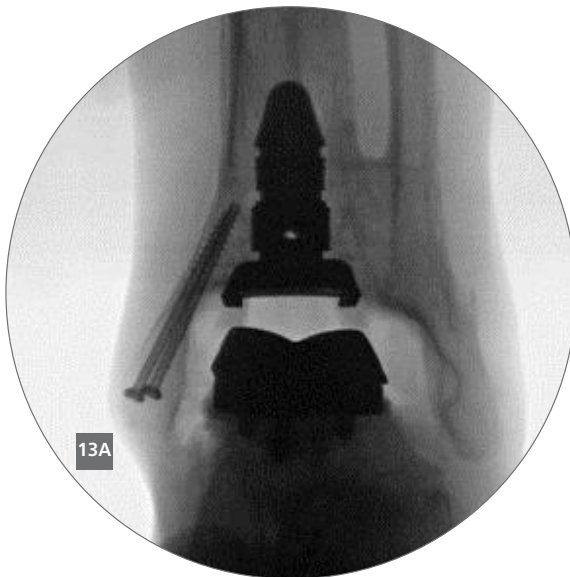
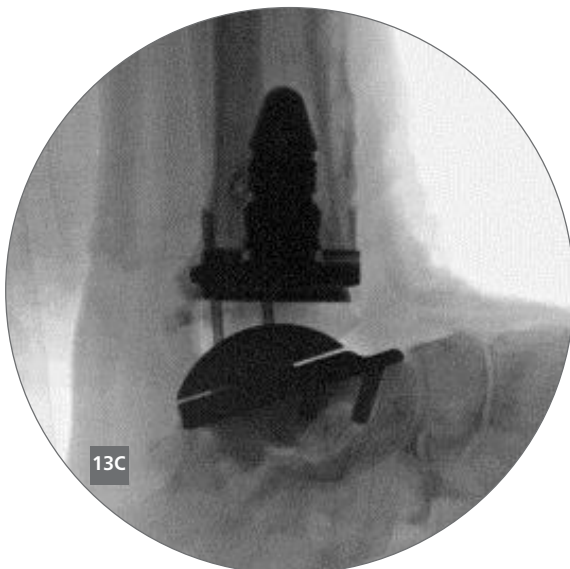
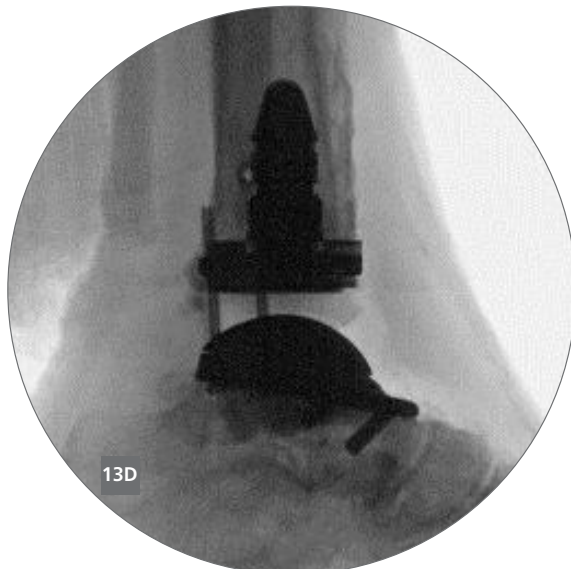
Final implant positioning with range of motion can be seen in FIGURES 13A, B, C, and D. The anterior peg is fixed rigidly in the talar head. To facilitate adjacent joint motion, the talar plate does not cross the talonavicular joint. Coronal plane imaging demonstrates excellent gutter debridement, which facilitates the true prosthesis motion.
