INVISION™ Total Ankle Revision System

Revision of a Failed Salto Talaris Total Ankle Replacement with an INVISION Tibial Component and an INBONE™ II Talar Component

CASE STUDY

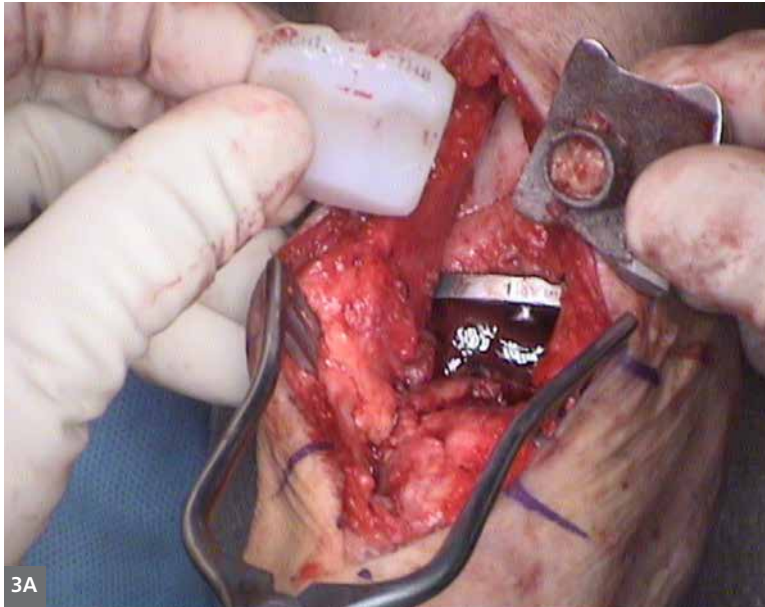
The previous anterior incision was used to expose the ankle joint. Cultures were taken as a precaution (results were negative), and the polyethylene was removed. The talus was removed with an osteotome with minimal bone loss (FIGURE 3A).

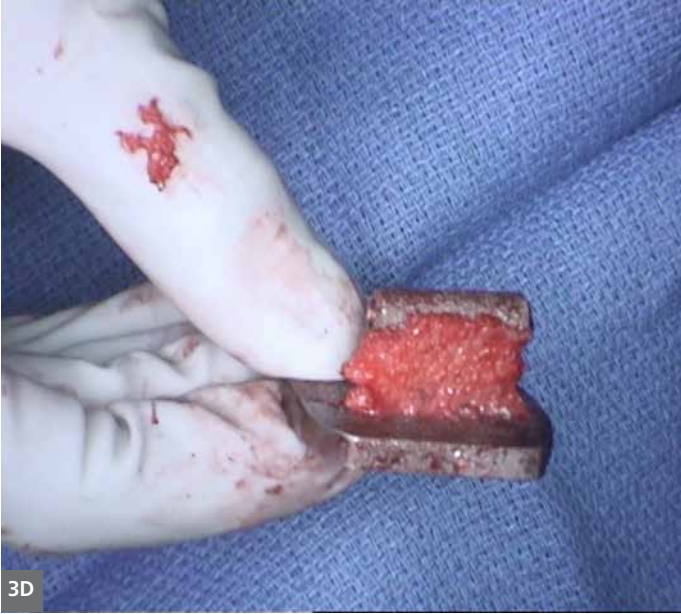
The tibial component showed ingrowth on the stem but no ingrowth on the tray suggesting stress shielding (FIGURE 3D).

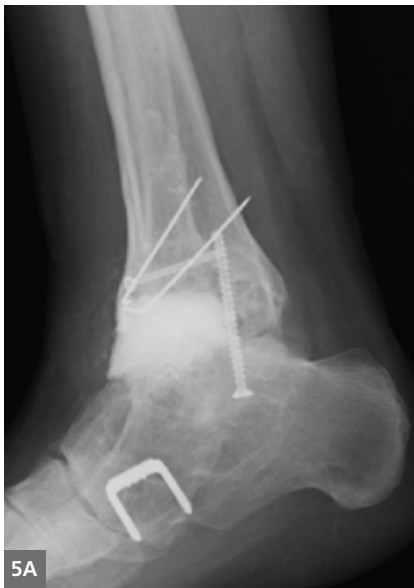
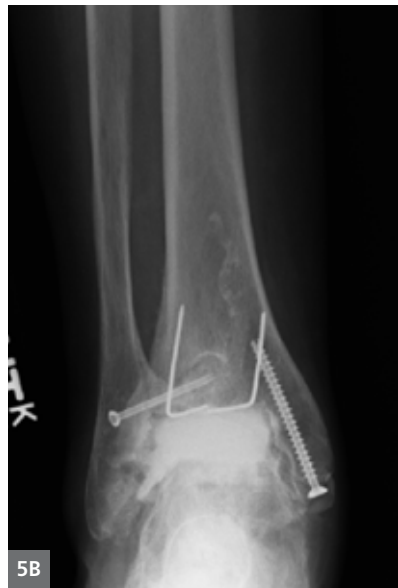
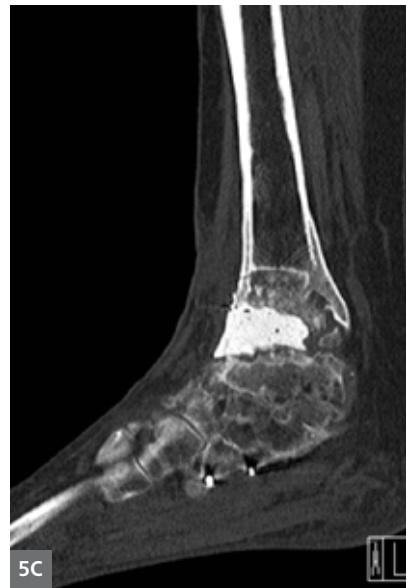
The wound was closed in layers. Postoperative x-rays and CT confirmed consolidation of the fracture and bone defects (FIGURES 5A, B, and C).

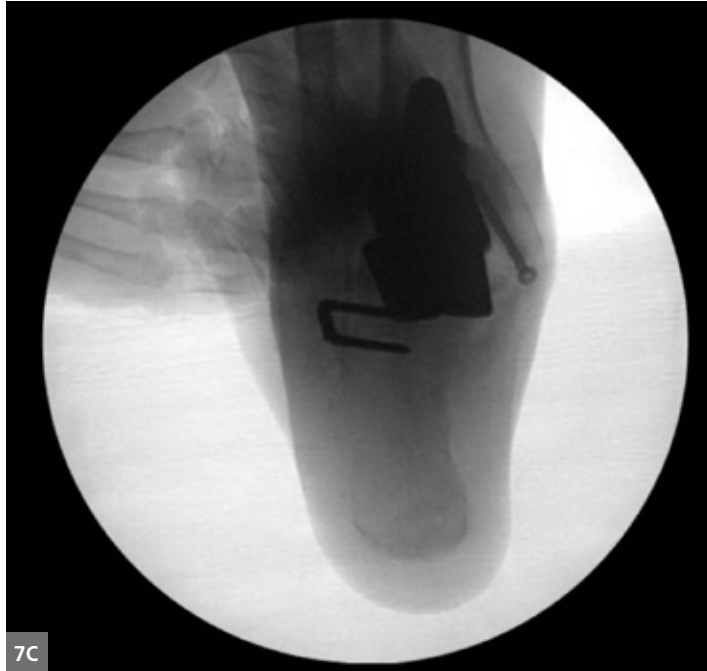
The polyethylene trial showed the need for a 12mm thick insert with excellent stability. An intraoperative axial view showed the valgus deformity was corrected (FIGURE 7C).

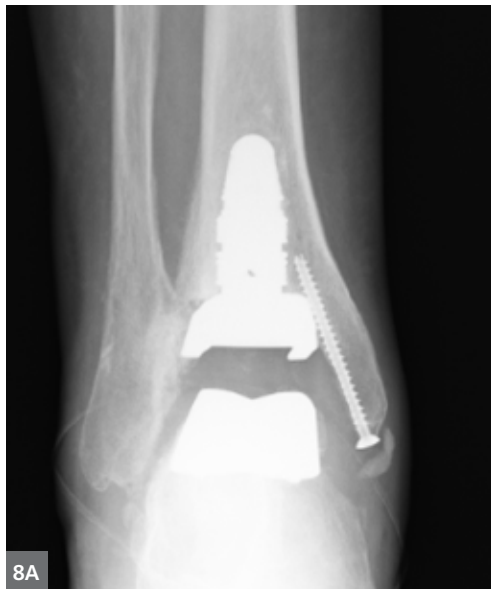
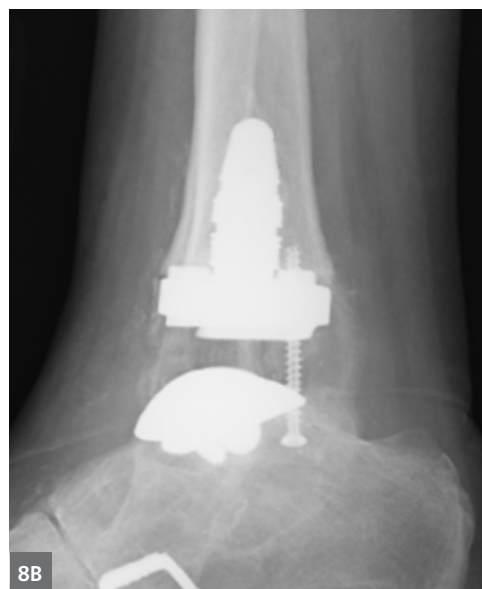
At her two month postoperative visit, the incision was healed, and she began protected weight bearing and physiotherapy (FIGURES 8A and B).
