INVISION™ Total Ankle Replacement System with PROPHECY™ Preoperative Navigation

Revision of a Failed Agility Total Ankle Replacement

CASE STUDY

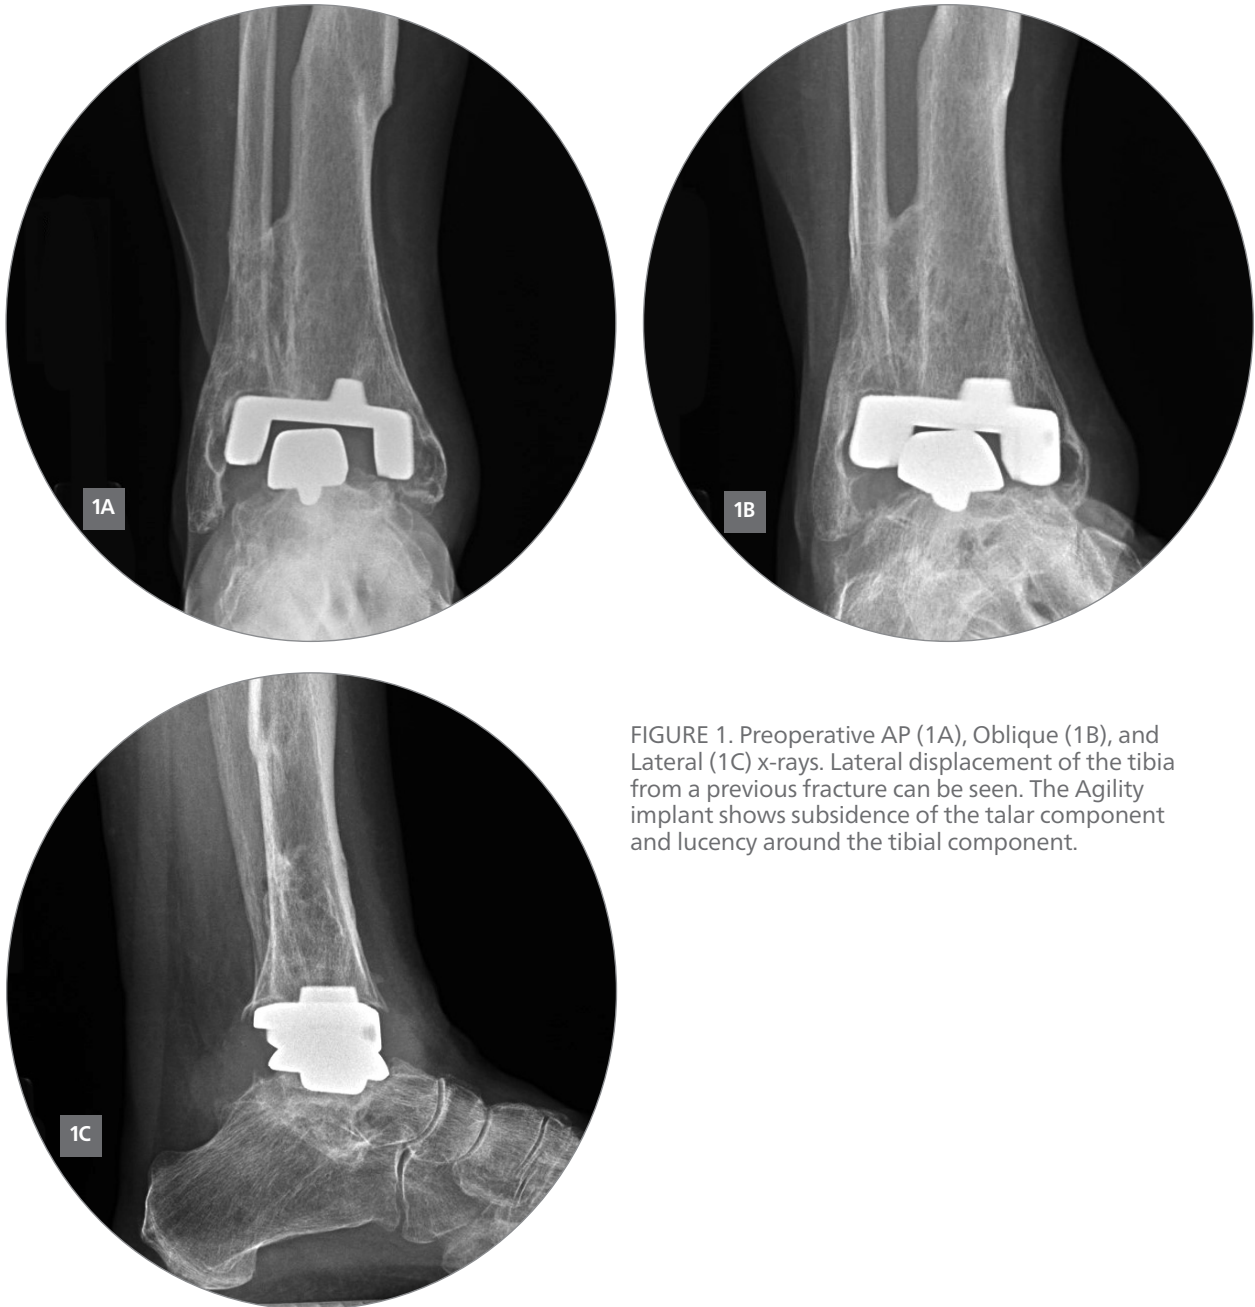
Radiographic studies demonstrated some subsidence of the Agility talar component and lucency around the malleolar borders of the tibial component, particularly the lateral side. (FIGURES 1A, B, and C).

FIGURE 1. Preoperative AP (1A), Oblique (1B), and Lateral (1C) x-rays. Lateral displacement of the tibia from a previous fracture can be seen. The Agility implant shows subsidence of the talar component and lucency around the tibial component.

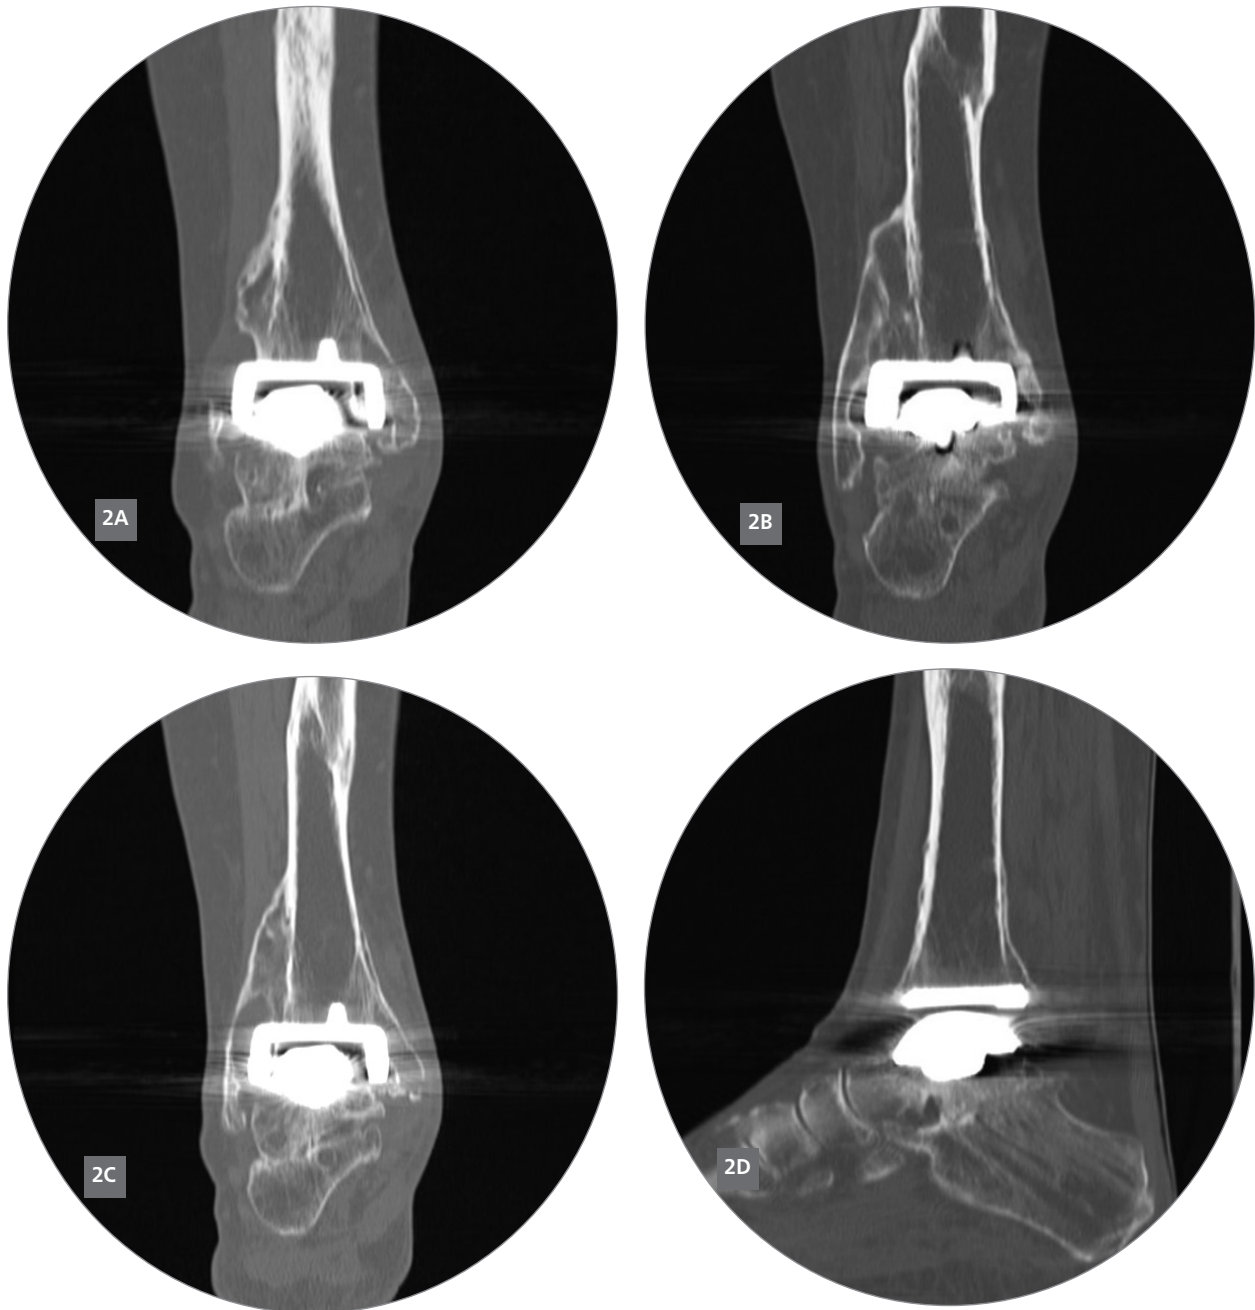
CT confirmed the radiographic findings and showed solid subtalar fusion (FIGURES 2A, B, C, and D).

FIGURE 2. Preoperative coronal (2A, B, C) sagittal (2D) CT scans confirming the existence of multiple radiolucencies adjacent to the agility implant and subsidence of the talar component and solid subtalar joint fusion.

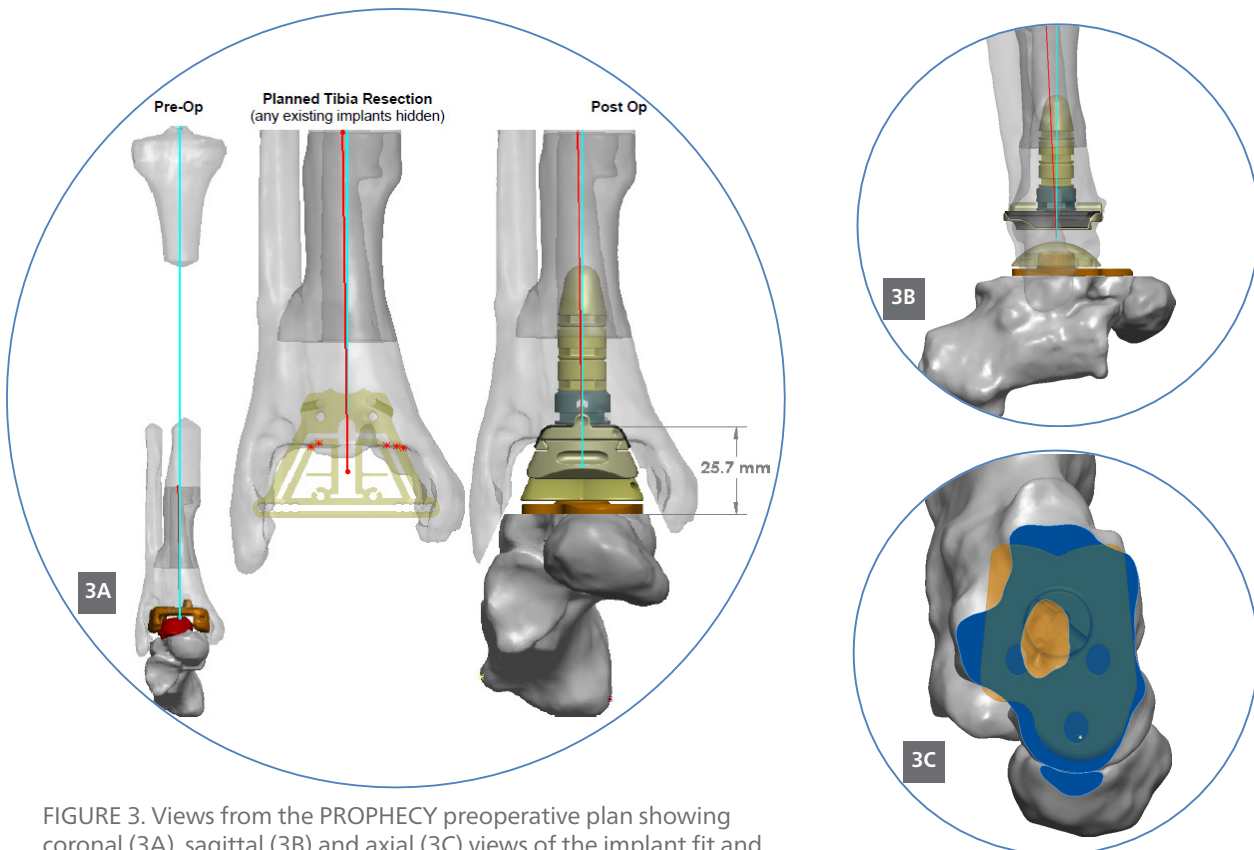
FIGURE 3. Views from the PROPHECY preoperative plan showing coronal (3A), sagittal (3B) and axial (3C) views of the implant fit and alignment.

We elected to use INVISION Total Ankle Revision with PROPHECY Preoperative Navigation to aid in the preoperative planning and orientation of the new implant. Using CT scans of the ankle, a PROPHECY alignment plan was created, reviewed, and adjusted (FIGURES 3A, B, and C). Alignment guides were then manufactured (FIGURE 3D). The perceived advantage of the system was the opportunity to determine appropriate alignment with respect to the mechanical axis of the native tibia despite the malunion of the original fracture. Additionally, rotational control could be evaluated based on real anatomic landmarks such as malleolar axis in reference to the tibial tubercle, which could only be “eyeballed” without three-dimensional information provided by the PROPHECY CT data.

Using this planning system, an INBONE™ tibial tray was identified to restore joint height and compensate for the bone loss related to the original implant. The 3mm thick INVISION talar plate would not only provide excellent perimeter coverage but also cover the talar fin defect left by the Agility implant.

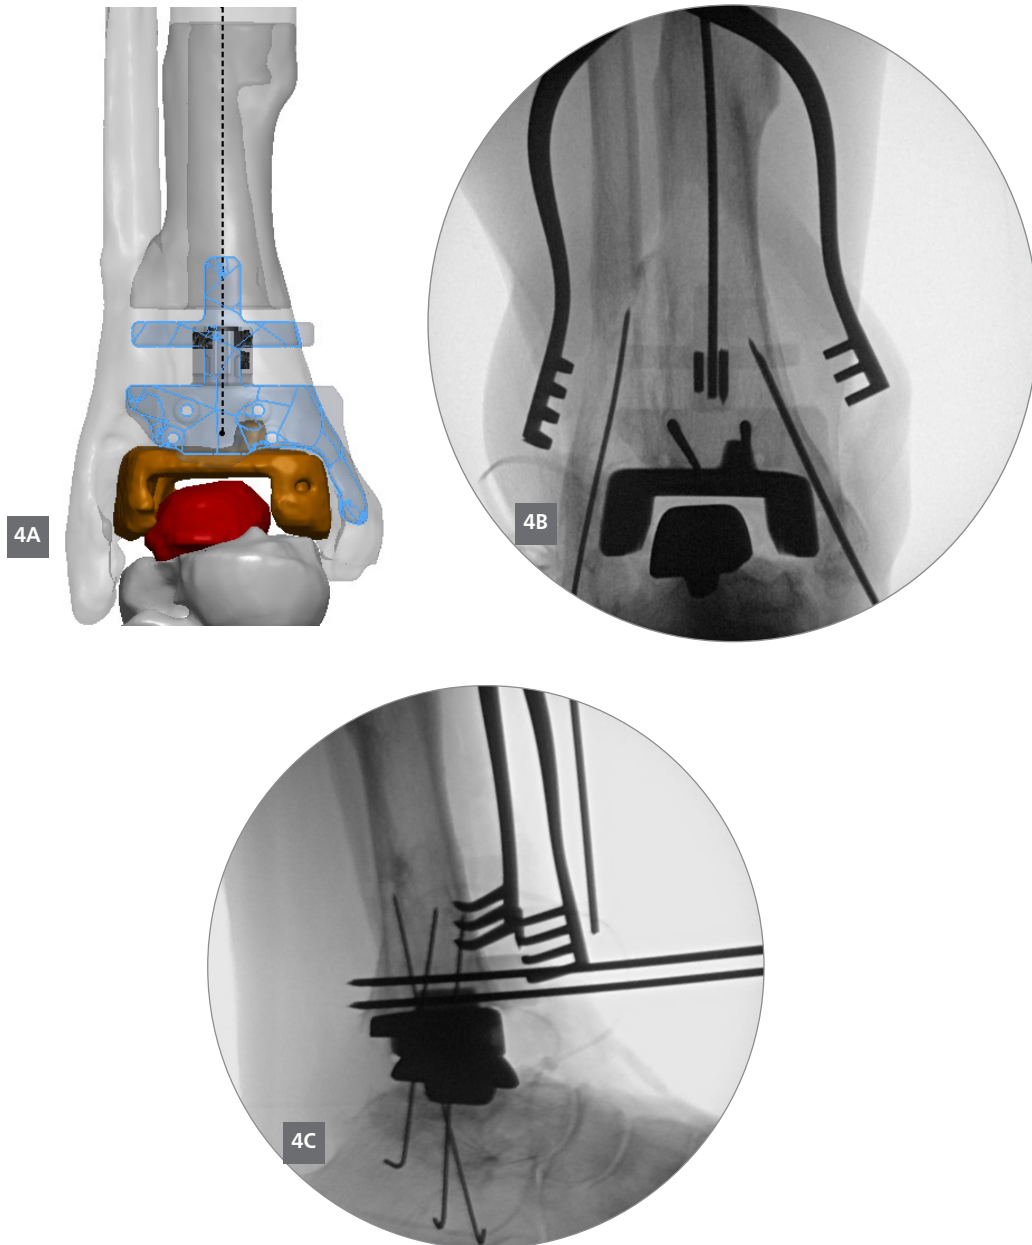
FIGURE 4. Model of the tibia alignment guide on the distal tibia (4A). Intraoperative fluoroscopy showing the AP (4B), and lateral (4C) views of pin placement prior to explant of the failed Agility implant.

First, the PROPHECY Tibial Alignment Guide was used to place pins to align the cut block in order to make the predetermined tibial cut after implant removal (FIGURES 4A, B, and C). Additional pins were placed prophylactically in each malleolus to aid in fracture prevention, as the malleoli were thin due to resection at the time of implanting the Agility and vulnerable upon its removal.

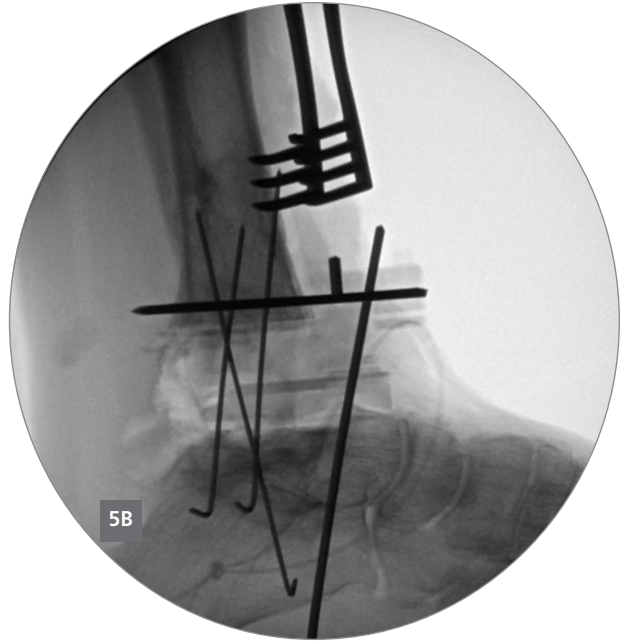
FIGURE 5B. Lateral view of the PROPHECY spacer guides which facilitate correct positioning of the talus under the tibia.

Once the Agility was explanted, the sequence was the same as that for a primary PROPHECY INBONE (FIGURE 5A) except that the talar resection was referenced from the tibial cut (FIGURES 5B, C, and D). Ankle deformity correction was accomplished by a combination of manual positioning of the foot plus the use of assistive, intra-articular, patient-specific spacer blocks to facilitate re-alignment of the talus bone based on the predetermined corrected state from the alignment plan. The final talus resection depth was adjusted manually and determined using lateral fluoroscopy.

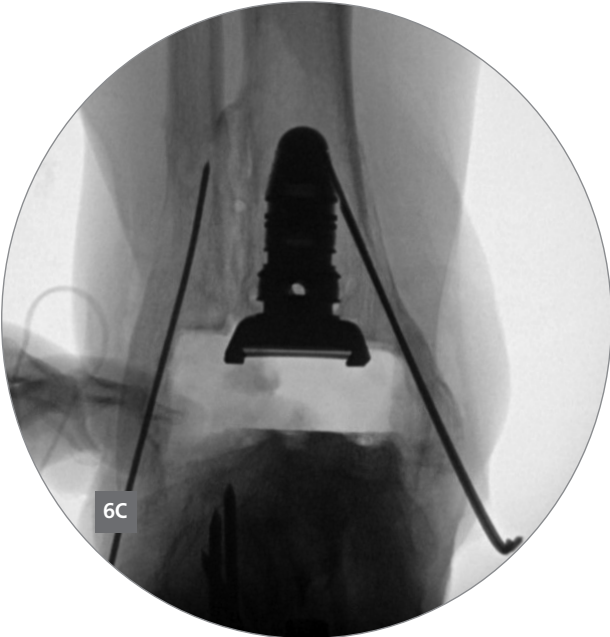
FIGURE 6C. AP view of the revision tibia prosthesis.

The remainder of the case followed the steps of a routine PROPHECY case, but using an INVISION talar construct instead of INBONE (FIGURES 6A-F).

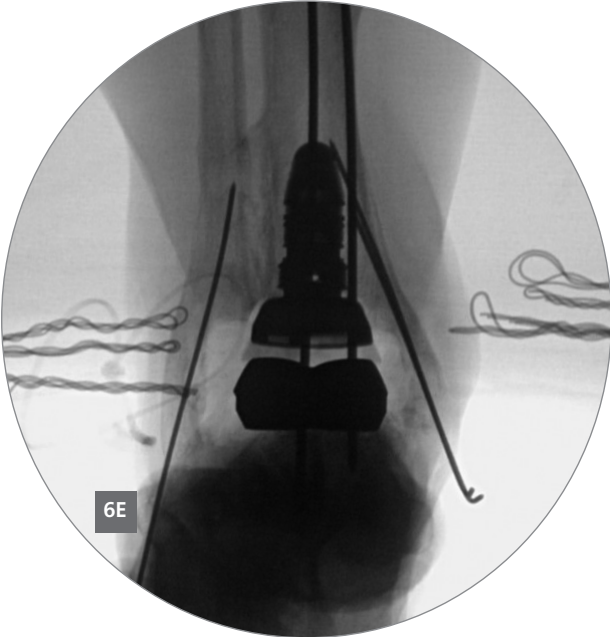
FIGURE 6E. AP view while trialing the INVISION talar plate and dome.

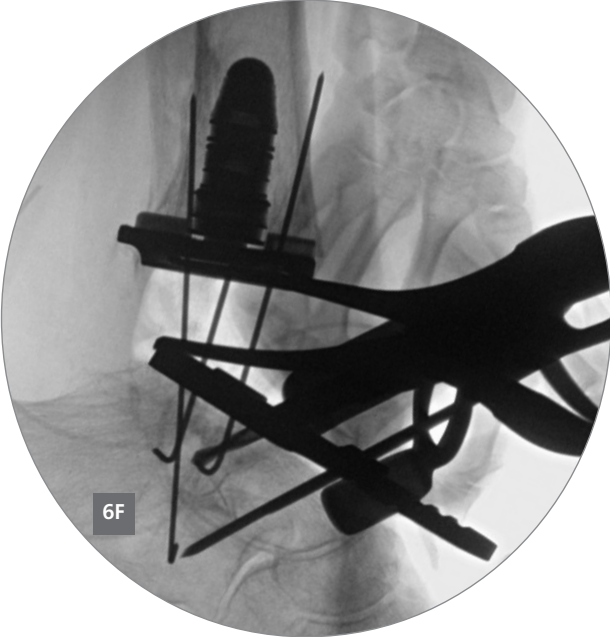
FIGURE 6F. Prepping the talar peg holes through the talar plate trial.

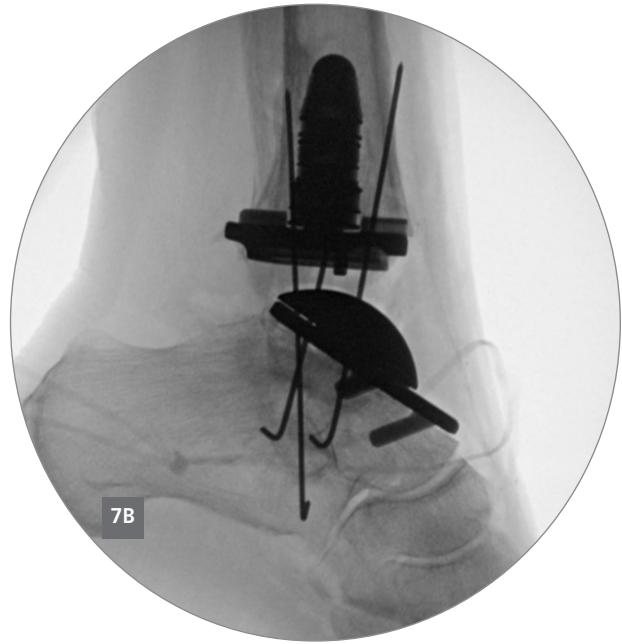
FIGURE 7B. Plantarflexion.

Intraoperative fluoroscopy shows excellent position of the implant with restoration of ankle height and good talar coverage and outstanding range of motion, which was better than preoperative (FIGURES 7A-B). To reduce the risk of postoperative malleolar fracture, cannulated screws were inserted into both malleoli over the existing K-wires (FIGURES 7C-D).

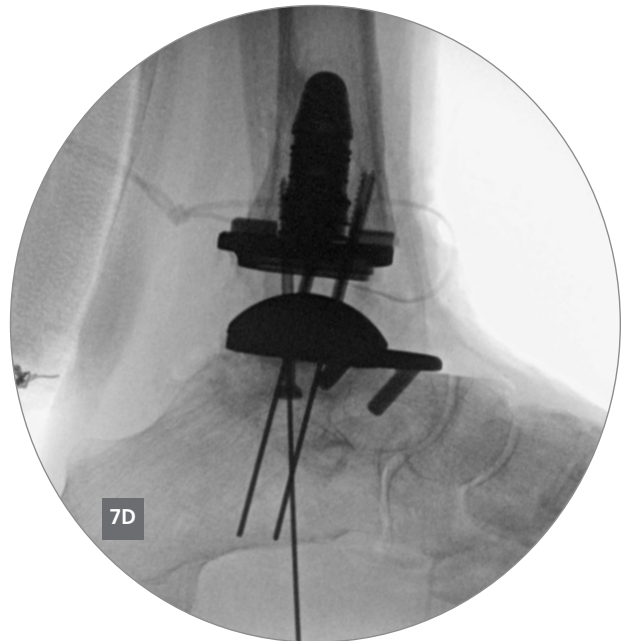
FIGURE 7D. Final lateral intraoperative x-ray.

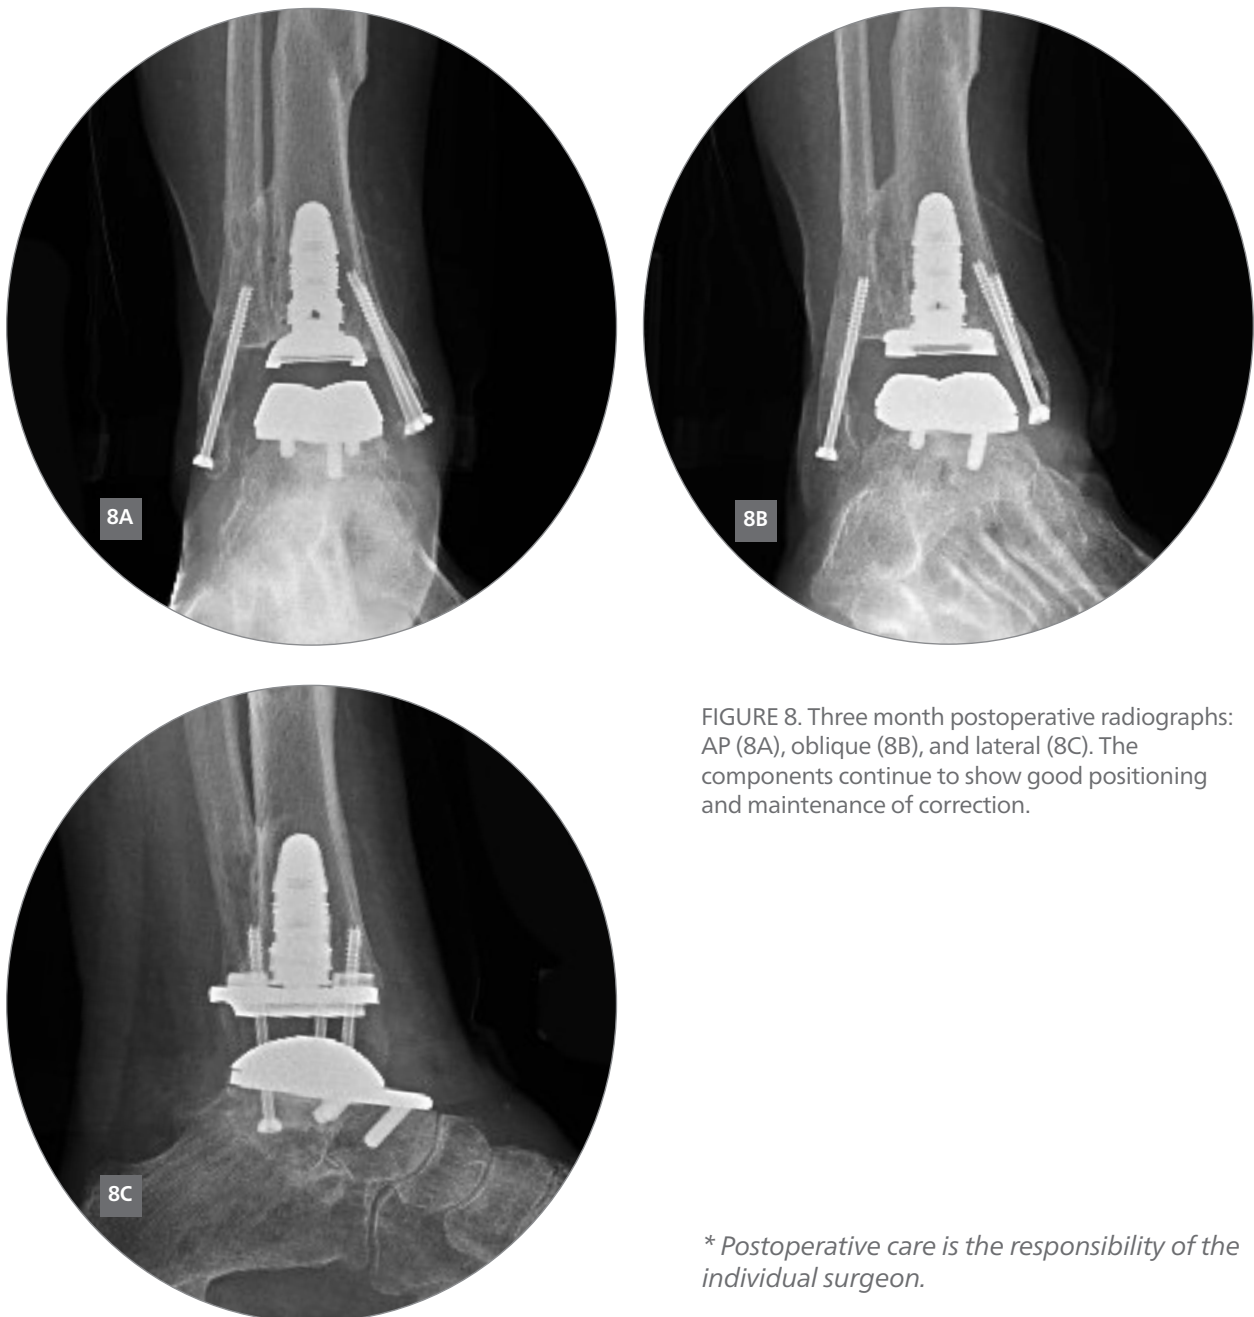
FIGURE 8. Three month postoperative radiographs: AP (8A), oblique (8B), and lateral (8C). The components continue to show good positioning and maintenance of correction.

At three months postoperative, the implant continues to show good alignment radiographically (FIGURES 8A, B, and C). The patient reports that her pain has improved substantially. She reports that her ankle pain is now less than at any time during the history of the previous implant. Her range of motion has improved to 40° plantarflexion (35° preop) and 10° dorsiflexion (5° preop). She walks without a limp and reports that her life has regained normalcy from pain relief and substantially improved function. To date, her postoperative recovery course has been uneventful.
